# **Sanitary Survey Report**

**Hopi High School – BIA Public Water System  
PWSID #0400395**

**March 23, 2018**

**Dan L. Fraser, P.E., and JanDee May  
Sleeping Giant Environmental Consultants, LLP**

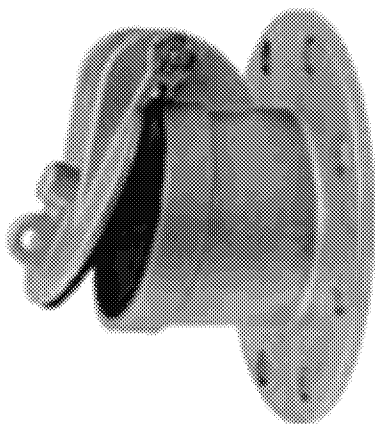
**Figure 2 - Example of a flap gate.**

4. **Storage Tank Deficiency (ST001– ST1 – Health Risk Priority 1) - Photo 15 and Figure 2.** The overflow for the elevated storage tank is stubbed out near the foundation of the tank where a splash pad has been installed to prevent erosion and protect the tank's foundation. The overflow is screened but the openings in the screen are too large to prevent the entry of water-seeking insects like bees and wasps.

Another acceptable method of providing protection for overflows is to install a weighted flap gate. In theory, the flap gate will open to allow overflowing water to escape and then will close when the overflow ceases. An example of a flap gate is shown in Figure 2 below.

Note that Figure 2 shows the end of the overflow pipe has been cut at a slight angle to ensure a more tightly closing valve. Some regulatory agencies prefer to have overflows with both a flap gate and internal insect screen. Regardless of the method selected to protect overflows from insects and vermin, regular inspection and maintenance is required. Screens corrode and need regular replacement and flap gates need to be lubricated and cleaned to ensure free movement and sealing.

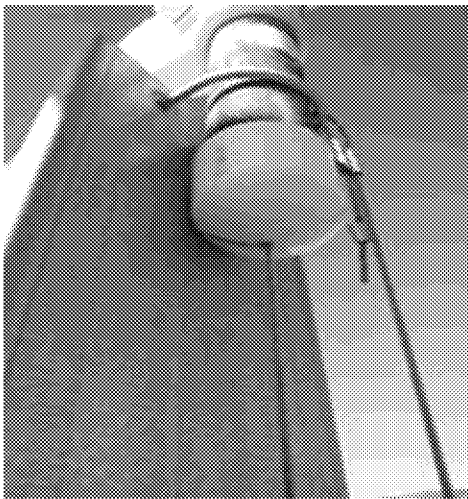
**Figure 3 - Installation of a PVC cap.**

7. **Target Cable Housing (ST001 – ST1 – Health Risk Priority 2) - Photo 15 and Figure 3.** The tank has a functional target; however, the housing for the target cable is not well sealed around the cable. The opening can allow insects to enter the storage tank. The cable housing's opening is over 100 feet above ground which will offer some protection against insects while making corrective action very difficult.

**Recommendation:** When the tank is inspected by a tank rehabilitation company, the target cable housing should be protected against the entry of insects. An option favored by the Region 9 program manager (and likely one of the best long term fixes) is to cover the lower few inches of the target cable housing with an appropriately-sized PVC cap.

The PVC cap can be inserted over the cable guide opening after a small hole is drilled at the appropriate location<sup>2</sup> in the cap (approximately 1/8 -1/4-inch diameter) and the cap is slit to slide over the cable. The cap and slit can be

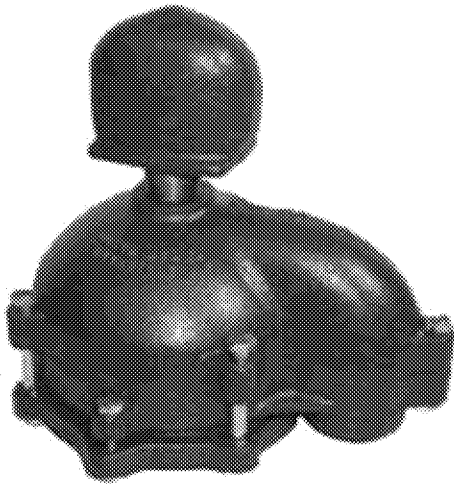
**Figure 4 - Sanitary seal with protected and screened vent.**

The three wells are all equipped with new sanitary seals. However, the sanitary seals do not have downward-facing screened vents. As water moves up and down in the well casings, during and after pumping, the casing's internal air pressure will change. Thus, air will be attempting to move into and out of the casings to equalize the pressure. With no dedicated vents, the air will move through the electrical conduits. This can force moist air into electrical controls causing corrosion and may allow contaminants to enter the casing. For example, if the buried conduit is submerged in shallow ground water, that water can be siphoned into the well casing. For these reasons, it is best to have properly designed dedicated vents.

**Recommendation:** Properly designed vents should be installed on all three wells. The sanitary seals now on the wells have a threaded port that is designed to accommodate a vent (Figure 4). This kind of vent should be available from the supplier of the sanitary seals.
